Greenheck Project Profile Midtown Global Market

Minneapolis, MN

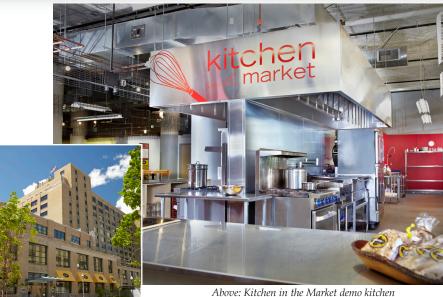
Above: Kitchen in the Market demo kitchen Left: Exterior Midtown Global Market with adjoining apartment building
